CORROSION OF GALVANISED AND UNGALVANISED COLD-FORMED STEEL IN CHLORIDE AND SULPHATE SOLUTIONS

Keywords: corrosion, durability, light steel frame, cold-formed steel, strength reduction

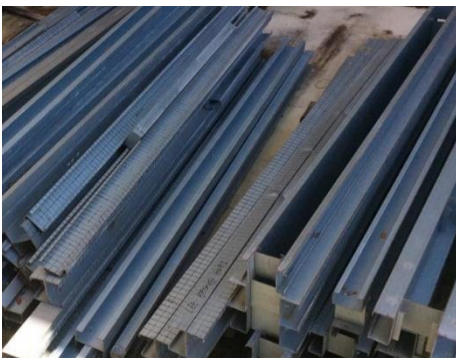
The coupon size is 100 × 50 mm from a 3 mm channel section of cold-formed steel. The cold-formed sections were cut into desired size using grinder. The tested cold-formed sections from previous beam flexural experiments were used, as shown in Figure 1. Galvanized or ungalvanized steel coupons were prepared for the immersion tests in chemical solutions.

Figure 1 Used channel cold-formed steel section for corrosion tests

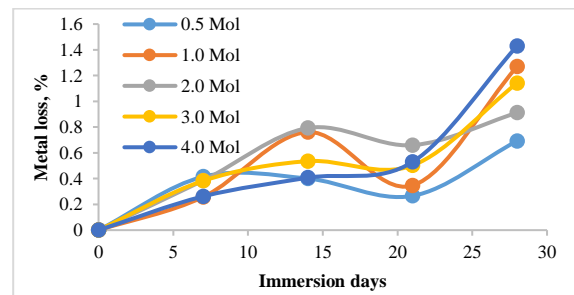
Figure 3 Corrosion rate for galvanized cold-formed steel coupons in NaCl

The corroded specimens can be visualized from Table 2. The corroded coupons revealed that there were no rusts (ferum oxide) found on the galvanized surfaces of the cold-formed steel coupons. Contrary, the rusts were observed in all surfaces. Figures 3 and 4 show the corrosion rate of immersed steel

coupons in different concentration of NaCl. Due to an exceedingly small difference of metal loss, removing of the corroded iron oxide may cause the fluctuation of the data in the graph illustrations. Generally, the corrosion rate increased with the increment of solution concentration and time frame for both galvanized and ungalvanized cold-formed steel coupons. According to [16], zinc is corroded as steel while exposed to the atmosphere, however, the corrosion rate of zinc is approximately 1/30 of steel.

While the corrosion reaction occurred, the zinc coating on the galvanized steel transferred the electrons to the environment enabling the formation of dissolved species (Zn^{2+}) from the zinc coating in the solution. Besides that, with the presence of dissolved NaCl, the NaCl solution is break down into sodium ions (Na^+) and chloride ions (Cl^-) which help to transfer the electron during the corrosion reaction. Hence, the higher the concentration of NaCl, more ion involve in the corrosion reaction and resulting in increased of corrosion rate.

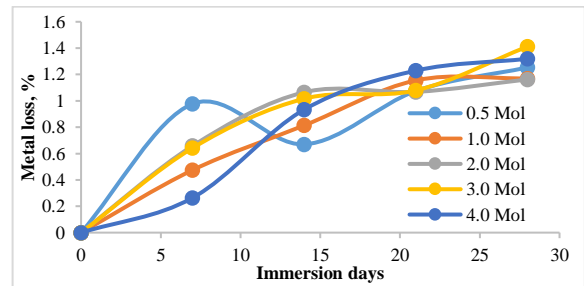
Figure 4 Corrosion rate for ungalvanized cold-formed steel coupons in NaCl

From previous study, a passive film of iron oxide is formed at the initial stage with more aggressive reaction [17] and the reaction is slowed down as the impermeable layer of the oxide preventing further chemical reaction with oxygen. This fact can be revealed on Figure 4 where higher rate at initial stage and lower rate at later stage for ungalvanized cold-formed steel coupons. As the immersion time increased, the formation of passive film is become more adherent and compact and decreased the diffusion and absorption of oxygen in the NaCl solution [18]. However, higher metal loss rate can be found in Figure 3 at later stage for galvanized cold-formed steel coupons. This is due to the zinc coating is consumed and exposed the steel to the corrosive environment and corrosion reaction is accelerated in later stage.

The highest corrosion rate for 7 days of immersion of ungalvanized steel was 0.5 Mol NaCl which is 0.07 g and the lowest corrosion rate was 4.0M NaCl which was only 0.02 g of metal loss. This can be clearly stated that the corrosion rate is decreased when the concentration of NaCl increased due to the formation of the ferrous hydroxide, $Fe(OH)_2$ which is insoluble in water is act as a barrier layer to isolate the steel from the environment. As the concentration of the NaCl solution increased, the barrier layer is converted to a thicker layer of ferrous hydroxide, $Fe(OH)_3$ and therefore decreased the corrosion rate of the steel.

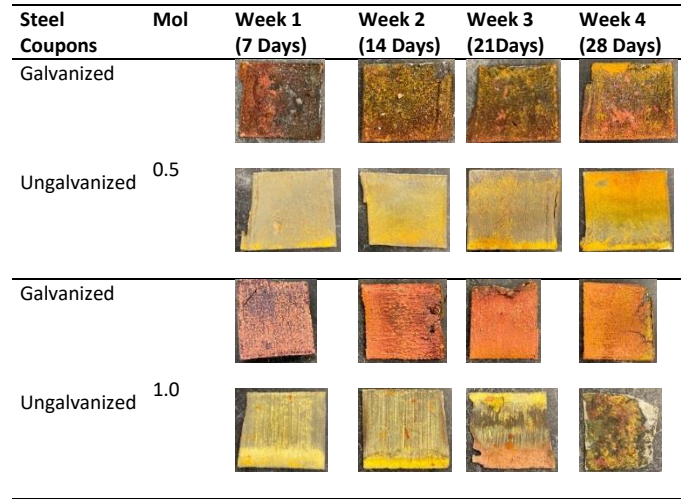
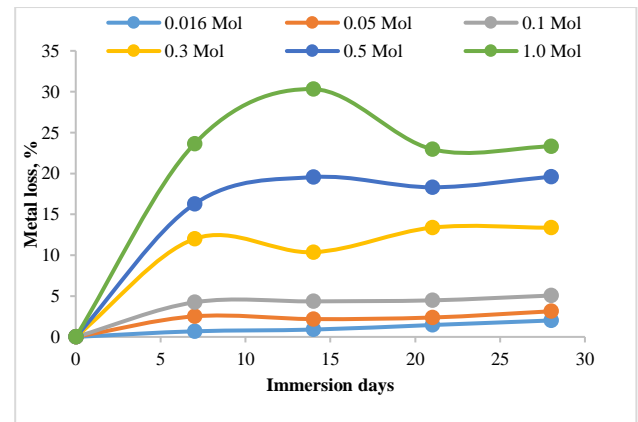
Figure 5 Corrosion rate for galvanised cold-formed steel coupons in CuSO_4

show the corrosion rates of galvanised and ungalvanised steel coupons in different concentration of CuSO_4 solutions.

The highest weight loss was discovered at the initial stage due to the redox reactions that occurred between the zinc coating surface and the copper ion in the CuSO_4 solution. The copper ion oxidized the zinc coating on the surface of the specimens. When the immersion time of the galvanised steel in the CuSO_4 solution increased, the corrosion rate of the galvanised steel increased. This is due to the decay of the zinc coating by oxidation process for a longer period of time which known as corrosion. Simultaneously, the copper ions that present in the solution are reduced to form copper metal that caused the CuSO_4 to become colourless [19]. The yellow rust can be shown on the surface of the galvanised steel. It shows that the longer the immersion time, the thicker the formation of the yellow rust on the surface of galvanised steel.

The weight loss of the galvanised steel is extremely lower than the un-galvanised steel whether in longer immersion time or higher concentration of the CuSO_4 solution. This has proved that the zinc coating is sufficient to reduce the corrosion rate of the steel. Zinc coating prevent the corrosive elements direct reaching to the steel that underneath as it acts as a sacrificial metal. Zinc is more easily to oxidize compare to steel. It consists lower reduction potential and resulting to be more active metal. Hence, the zinc shall be oxidized prior to the steel even the zinc coating has been scratched.

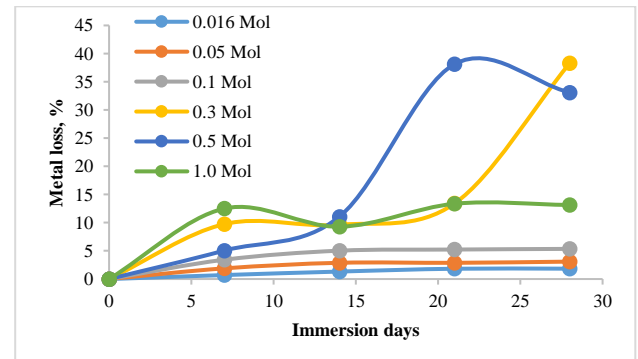
Figure 6 Corrosion rate for ungalvanised cold-formed steel coupons in CuSO_4

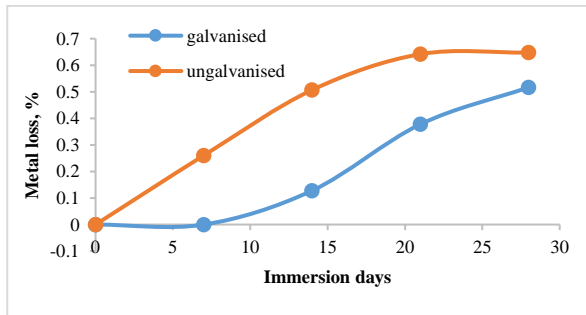
Figure 7 shows the corrosion rates for both galvanized and ungalvanized cold-formed steel in the collected natural rainwater. In the immersion period of 7-days, there was no metal loss found for galvanized steel coupons. The overall corrosion rates were lower than those immersed in chloride and sulphate solutions.

Figure 7 Corrosion for cold-formed steel coupons in natural rainwater

Previous research revealed that the corrosion rate of the galvanized steel is high initially due to the amount of reactants between the galvanized steel and the rainwater is high [15, 21]. However, the amount of reactants decreased following by the immersion time of the galvanized steel and therefore resulting in decreased of the corrosion rate. Besides that, the corrosion rate reduced following the immersion time is due to the protective film that formed on the surfaced of the galvanized steel [21]. The protective film is known as zinc carbonate. This protective film reduced the corrosion rate of the galvanized steel by avoid the rainwater dissolved and contact the zinc coating surface easily. However, the formation of the protective film has assisted the galvanized steel became superior corrosion resistance for long time exposure of the galvanized steel.

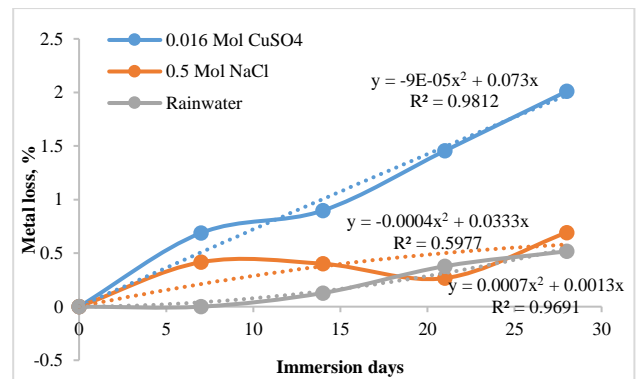
Figure 8 Metal loss prediction for galvanized cold-formed steel in 0.016 Mol CuSO₄, 0.5 Mol NaCl and rainwater

The weight loss is increased following the immersion time increased. This means that the corrosion rate is increased following the service life of the steel framing. However, the corrosion rate of the galvanized steel is decreased following the immersion time in the solution due to the dramatic patina that formed on the surface of the galvanized steel, but it might undergo corrosion throughout their service life. Therefore, it is significant to determine the durability of the steel framing during their service life to ensure they are still sufficient to provide services. The trendline of the 0.5 Mol NaCl in this study remain unclear with lower R² value and further justification is needed, as shown in Figure 8.

Figure 8 shows the weight losses per m² of the galvanized steel specimens against the immersion time in the 0.016 Mol concentration of CuSO₄ solution. It can be shown that the weight losses are increased while the immersion time increased. It means that the corrosion rate is increased following by their service time. Hence, it is important to study their durability throughout their service life to avoid failure of the structure occurred. Eq. 2 can be obtained from the graph and used to predict the metal loss.

$$\text{Metal loss in \%} = -0.00009 \times \text{exposure time} + 0.073 \times \text{exposure time} \quad (\text{Eq.2})$$
